**Monterey Bay Sanctuary Citizen Watershed Monitoring Network**  
299 Foam Street Monterey, CA 93940 Bus. (831) 883-9303 Fax (831) 883-4748

# **First Flush Report**

**October 30, 2001**

**In the Cities of  
Monterey, Pacific Grove and Santa Cruz, CA**

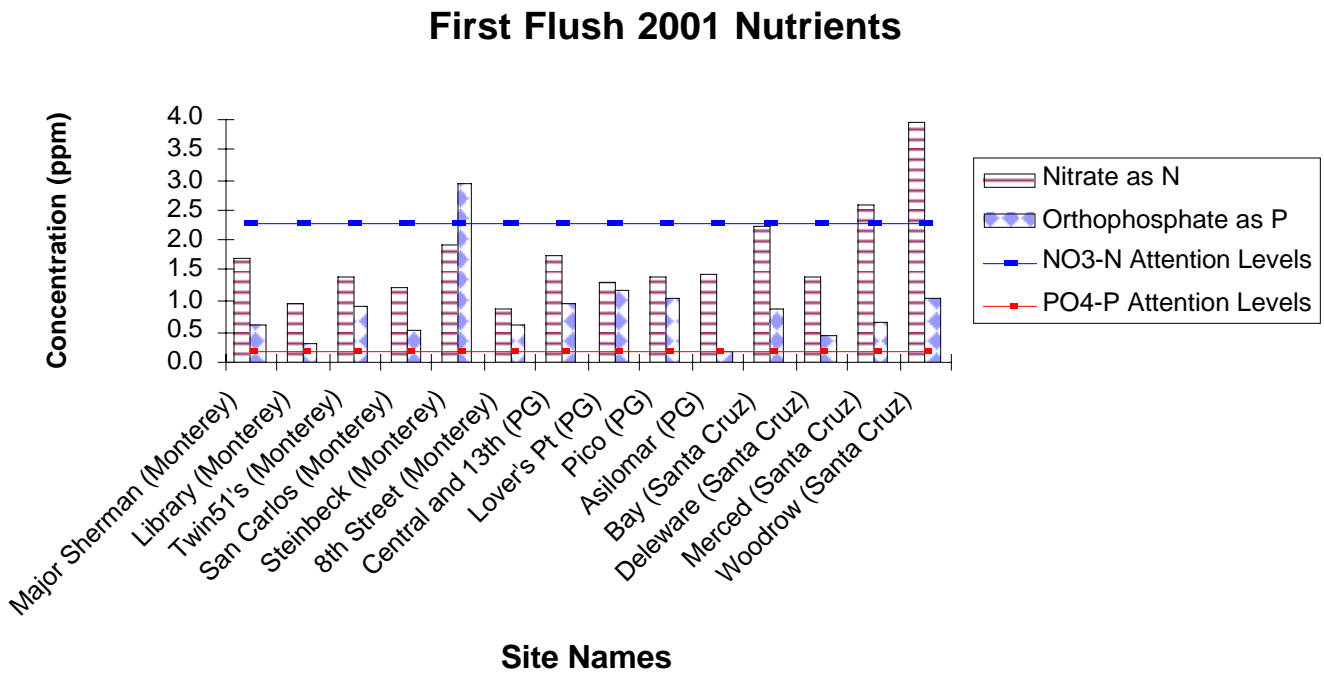
Figure 1. Orthophosphate as P and Nitrate as N concentrations (ppm) at storm drain outfalls during the First Flush Event. The stations are listed in order traveled from east to west by city. The straight lines depict the CCAMP Action Levels. The values for time series locations reflect the maximum result.

Phosphorus is a critical element for growth in plants. It is usually the growth-limiting factor for plants because it is present in very low concentrations in the environment. Orthophosphate is a form of phosphorus commonly found bound to soil particles, in sewage, fertilizers and in detergents that contain phosphates. Orthophosphate is rapidly taken up by algae and other larger marine plants. With excessive amounts present, large algal blooms occur. The CCAMP Action Level for orthophosphate ( $PO_4^{3-}$ -P) is 0.16 ppm (mg/l). This year, all of the stations exceeded 0.16 ppm. For the second year in a row, Asilomar had the lowest orthophosphate level at 0.18 ppm and Steinbeck Plaza was significantly higher than the other sites with a concentration of 2.9 ppm (See Figure 1).

Nitrogen is also an element that is needed for plant growth. It is much more readily available in the environment than phosphorus. Nitrogen is more readily available than phosphorus because nitrate is more soluble than phosphate. Plant growth is generally limited by phosphate, and not nitrate concentrations. Some sources of nitrate include runoff from fertilized lawns, agricultural and pasture lands, construction stations and septic leachate. The Action Level established by CCAMP for nitrate ( $NO_3$ -N) is 2.25 mg/l. All of the stations in Monterey and Pacific Grove were below this action level. In Santa Cruz, the Merced site had a concentration of 2.58 ppm and Woodrow reported 3.93 ppm. Bay Street was also very close to exceeding the action level at 2.24 ppm (See Figure 1). In 2000, no sites exceeded this action level.
